Logbook

It's a start...

OBie goes under the angle grinder and professional decorators enable Simon to finish in peace and quiet.

Model: 1967 Mk1 Austin Mini
History: Bought by my dad as a present for my mum in 1977 and used as a daily drive until 1991
Mileage before restoration: 93,063 miles

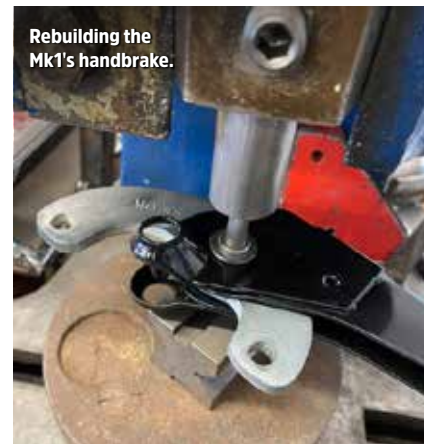
Rebuilding the Mk1's handbrake.

It's amazing how much a rub down and a coat of paint transforms some parts.

A quick look over the old handbrake and I could see it was worn and would

have to be repaired and restored. As spare parts aren't readily available, I took my time carefully to press out the rivets for re-use. When apart, everything looked promising and would clean up well, apart from the crossbar that holds the cables, as this was badly worn – too many handbrake turns probably. The easiest solution was to make a new one from stainless steel bar. Once I had repainted the handle and wire brushed the ratchet bracket, all the parts could be riveted back together again. I used a little copper grease on the moving parts and took it gently when setting the rivets. Too much force and the handbrake would be too stiff to operate properly.

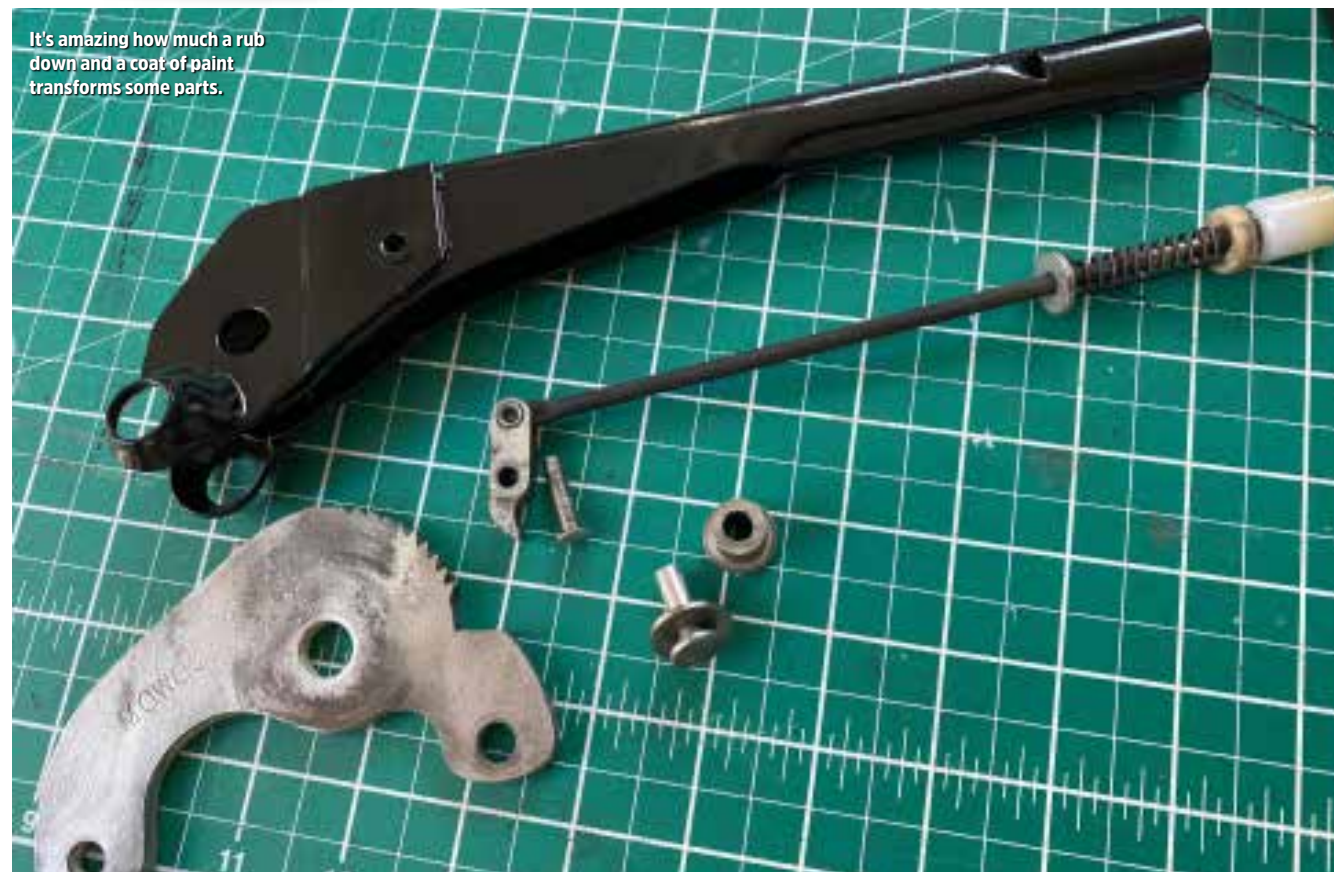
"...a lucky dip into one of the boxes finds the handbrake and the door locks."

Anyway, at last I can get my hands dirty and a lucky dip into one of the boxes finds the handbrake and the door locks. I was going to have to get a move on now with all the bits, so started work on some of the quicker and easier tasks first. The original locks worked OK but had some stress cracks in the cases around the latch bolt.

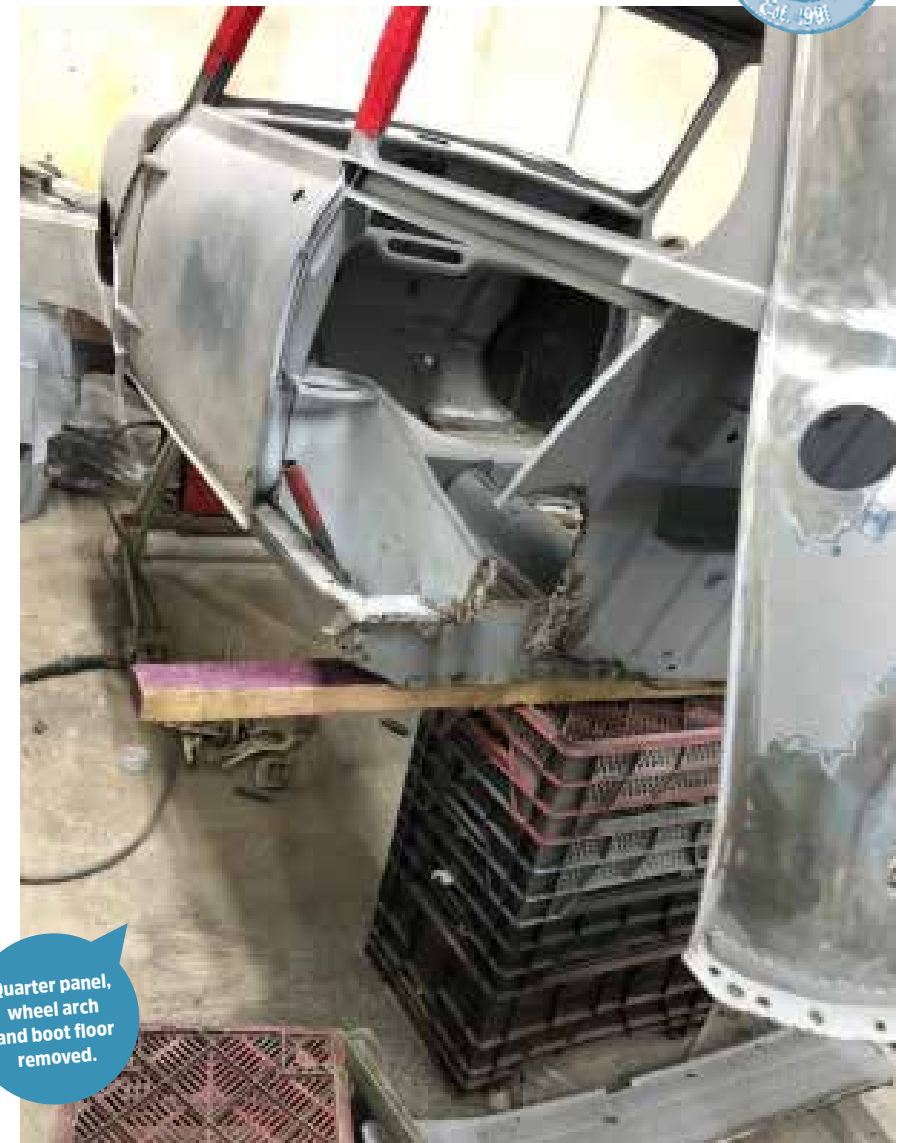
Quarter panel, wheel arch and boot floor removed.

So for me, it's a start, as the first interior parts are now ticked off the list. Over at Bridge Classic Cars there has been some more serious surgery on the shell. With even more panels removed she was looking very fragile and virtually

unrecognisable. In this delicate state, the body is cut back now about as far as they can go without it falling apart. What remains of the shell needs very careful support to hold it in shape before the new panels can be tacked into place. Once the structure is stiffened up again, she can then go back on the jig for the rest of the work to continue.

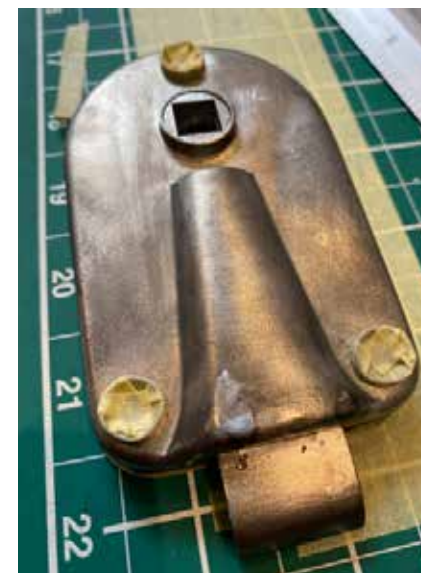
The repaired lock case masked up for painting.

I repaired these by grinding a 'V' groove along the cracks and then delicately filling them with weld. After a bit of finishing, and some time on a wire brush wheel, they are now ready for paint.

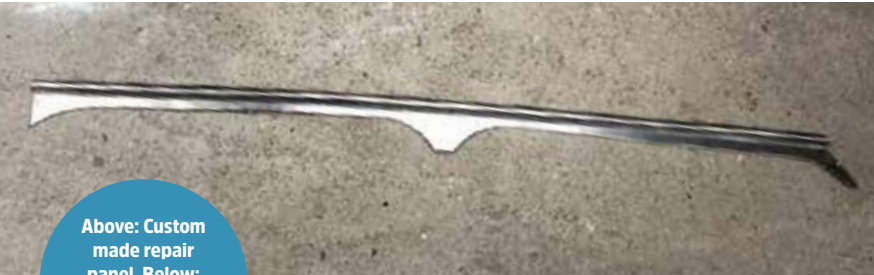
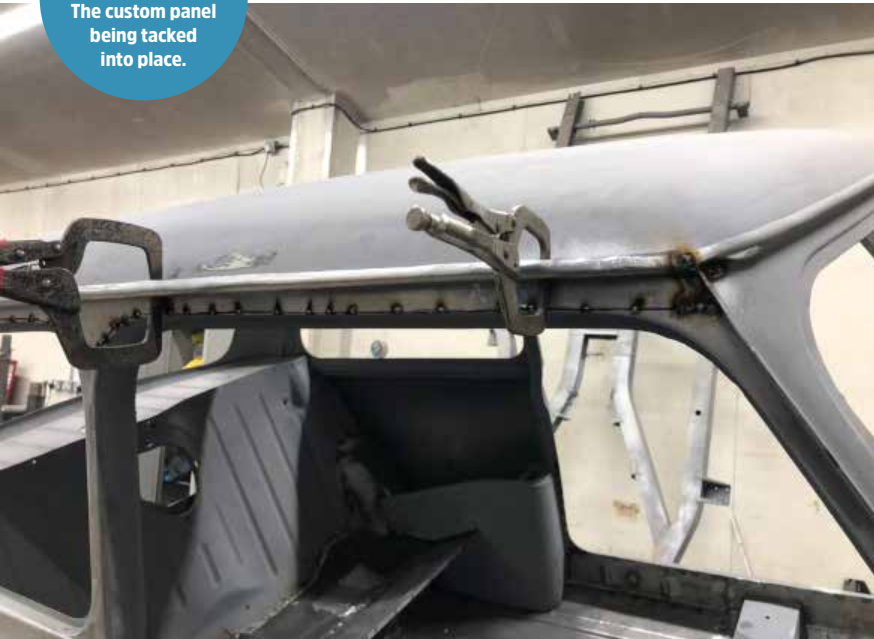
In the meantime there was plenty still to do elsewhere. Some rust perforation around the rear quarterlight window and door frame meant Anthony would be kept busy. Where replacement panels aren't »

Above: Custom made repair panel. Below: The custom panel being tacked into place.

available, some custom sections had to be made to repair localised bad areas.

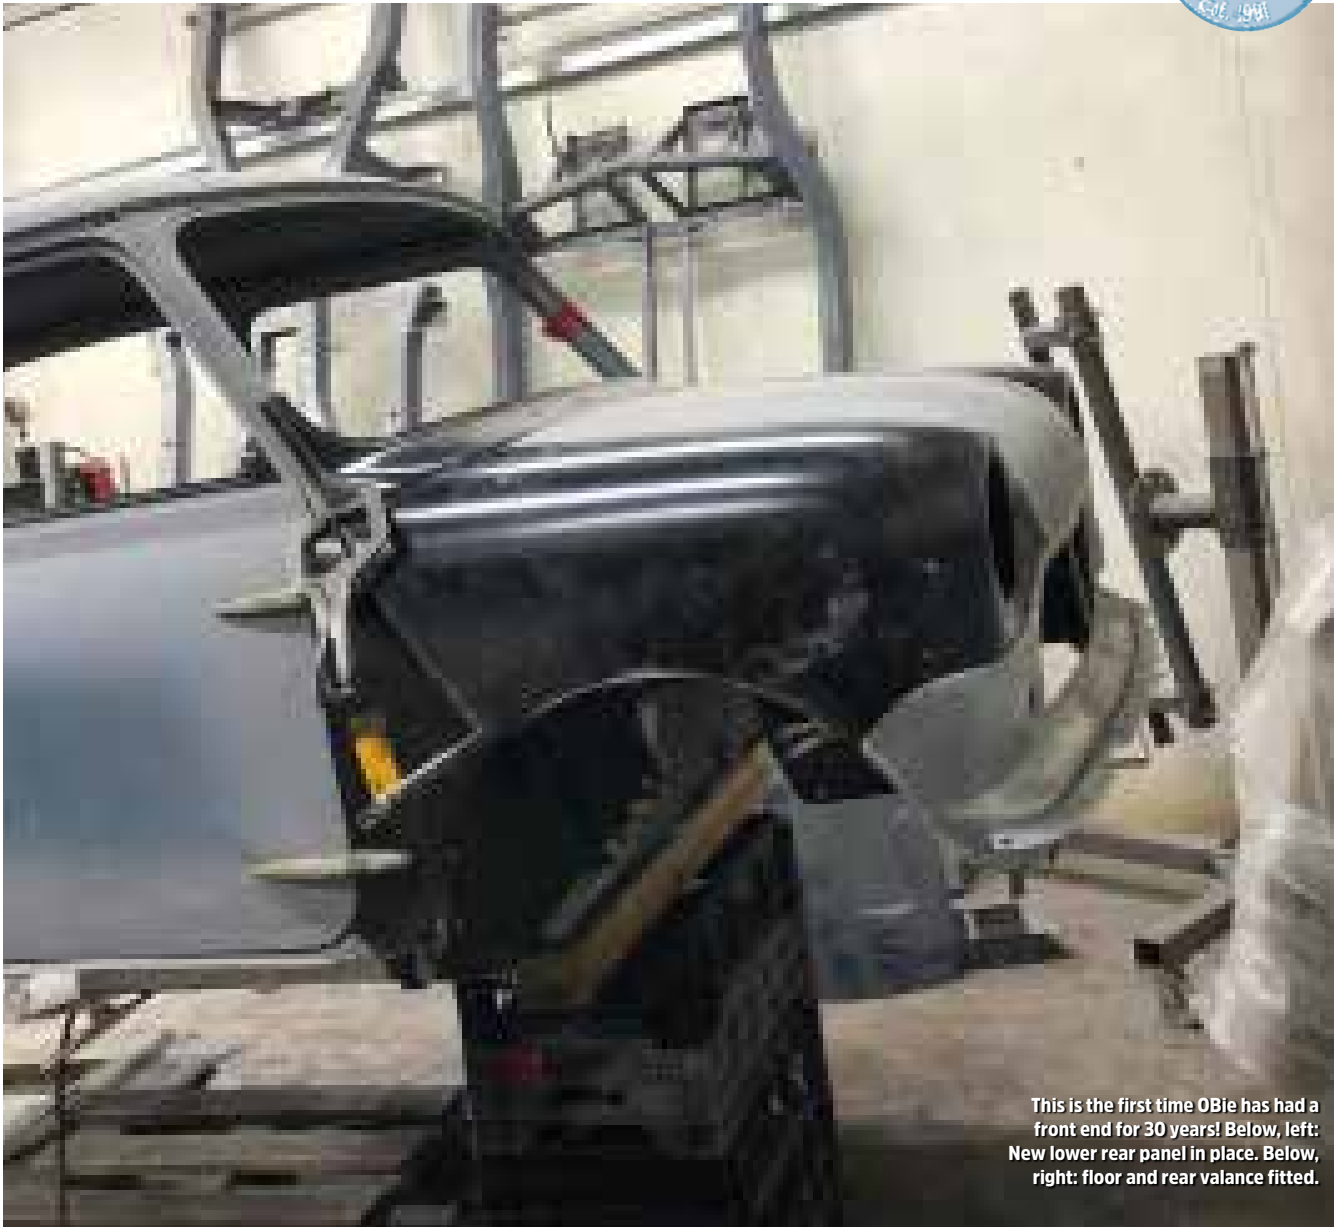
Working at the back of the Mini we could see that the lower rear panel wasn't good under the tail lights and around the boot opening. To repair would mean a good amount of filler to get the surface back and with so many sections removed, rather than bodge it, now was the time to replace it even though it would take a while for the new panel to arrive.

This is the first time OBie has had a front end for 30 years! Below, left: New lower rear panel in place. Below, right: floor and rear valance fitted.

Moving to the front of the car and what a transformation! The floors and flitch panels are in and the new scuttle has been fitted. This was modified to have just the one set of wiper holes as was correct for Mk1s. The A-panels also are now in place which means the wings, bonnet and front panel can be offered up for a test fit.

Once the rear panel arrived, no time was wasted getting it fitted and cleaned up. The bonnet and boot need some minor repairs and then it's just the doors to repair and re-skin and the car is very nearly ready for paint.

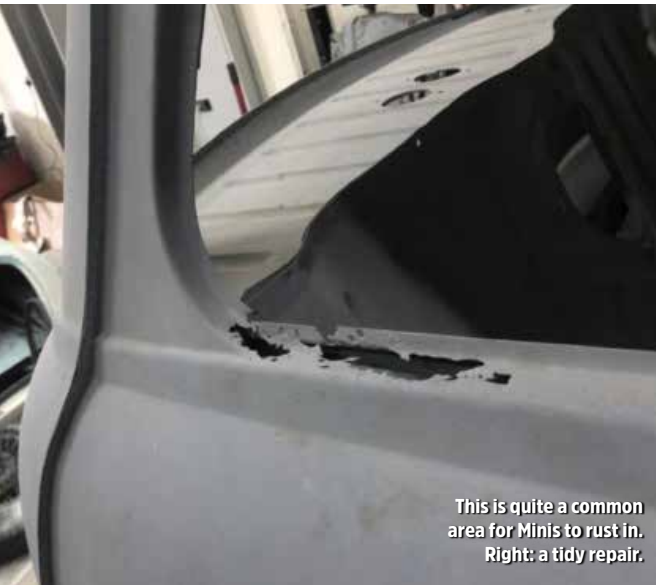
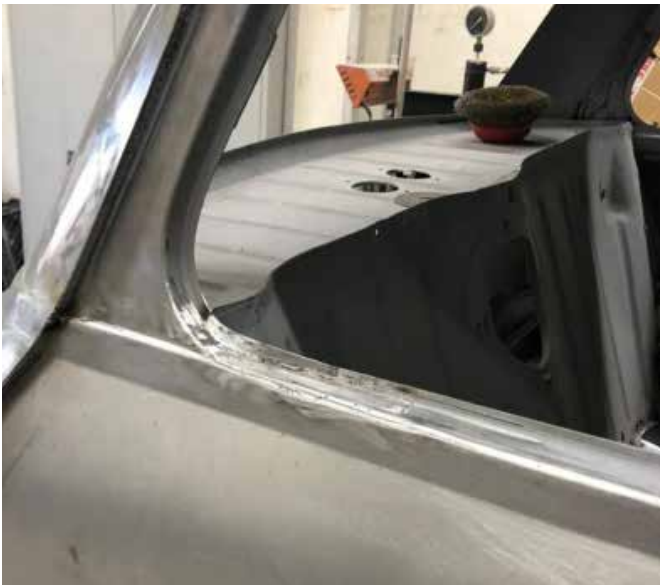
This is quite a common area for Minis to rust in. Right: a tidy repair.
